BUILDING 32 QUARTERMASTER'S STOREHOUSE

Fort Hancock, New Jersey
Sandy Hook Unit, Gateway National Recreation Area

HISTORIC STRUCTURE REPORT

Judith Q. Sullivan

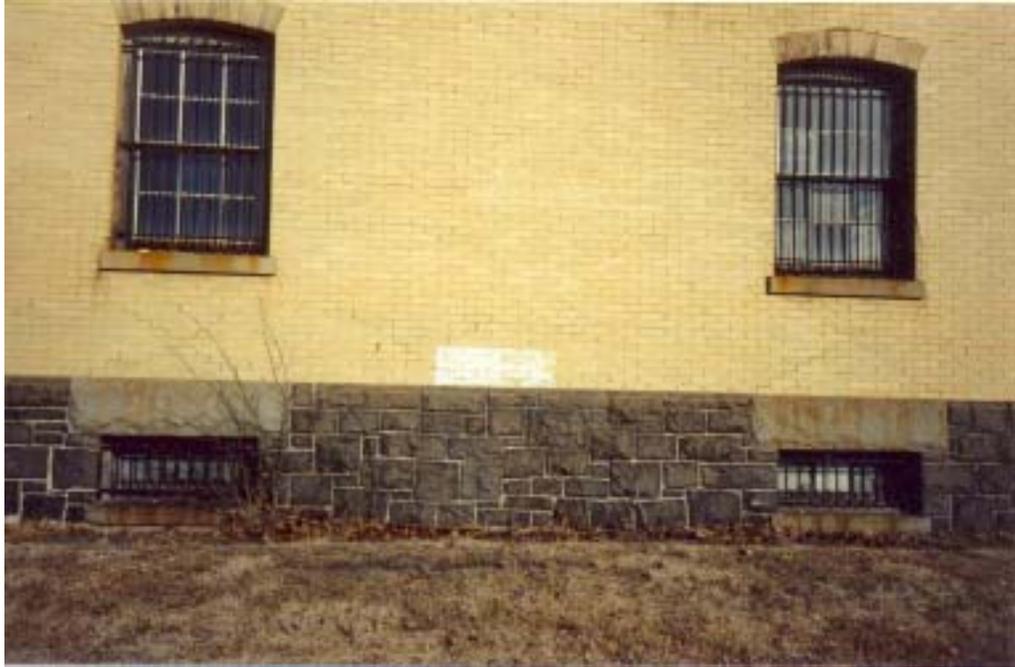
The foundation (*see figs. 44- 47*) is constructed of trap rock resting on a continuous concrete footing 1 foot thick and 2 feet wide. The foundation is 10 feet high and 1 foot 9 inches thick. Some 3 feet 7 inches of the foundation is above grade, while 6 feet 5 inches is below grade.

Figure 44. Foundation, south gable end [1993].

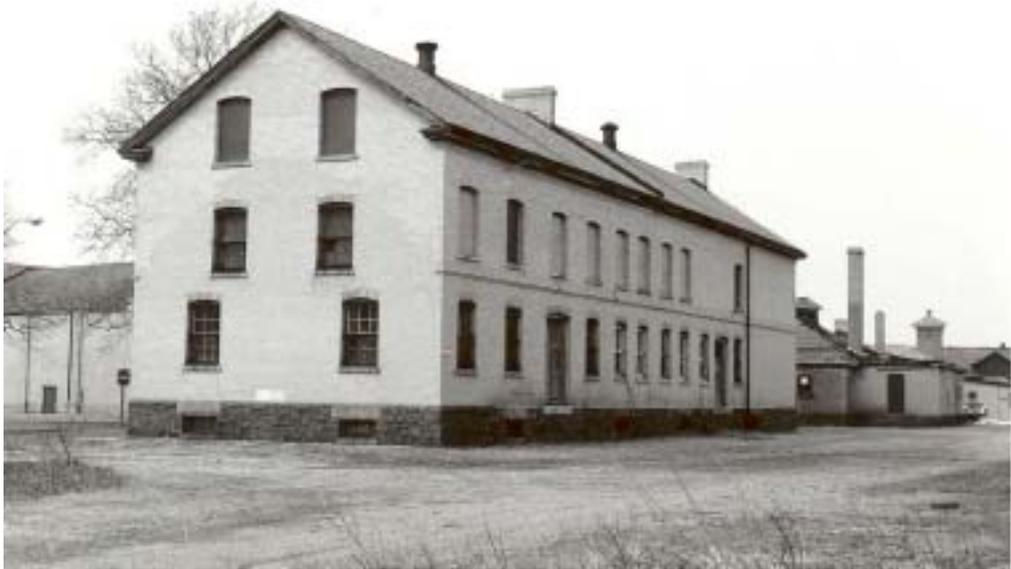
The exterior walls (*see figs. 48- 53*) are 1 foot thick. They consist of three wythes of brick: an exterior wythe of buff face bricks laid in stretcher bond with narrow joints, and two interior wythes of larger, red backing bricks. The face bricks are buff- colored bricks consistently measuring 8 by 2 ¼ by 4 inches. They are laid in stretcher bond with narrow (one- eighth- inch) flush joints. The backing bricks are low- fired red bricks generally measuring 2¼ by 7 7/8 by 3½ inches. They are laid in

Figure 49. South and east elevations, showing change in brickwork of south gable- end wall [1993].

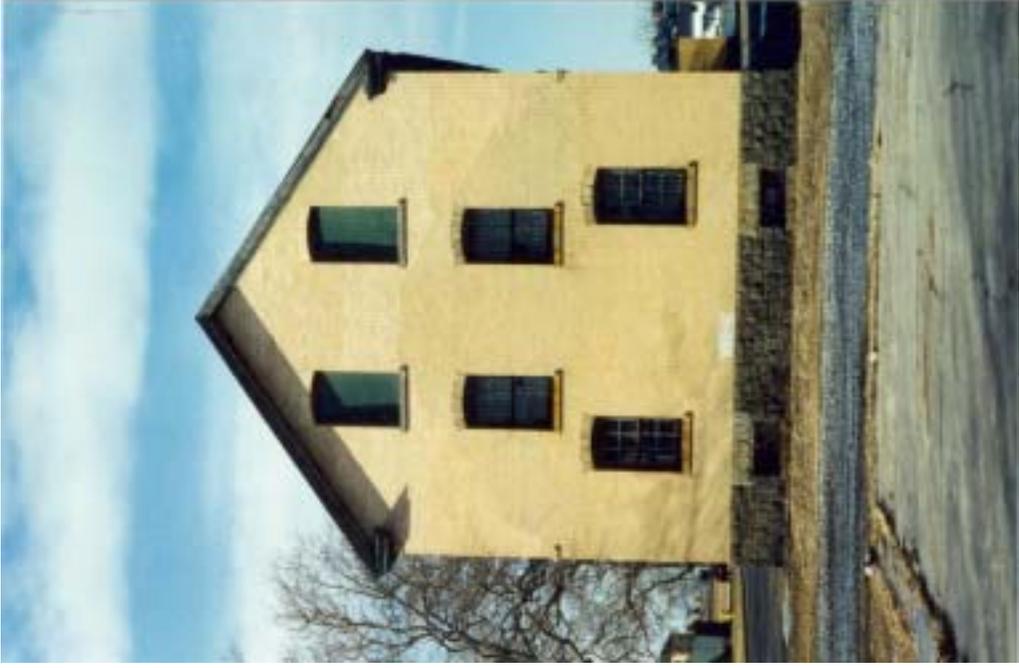
Figure 51. South elevation [1993].

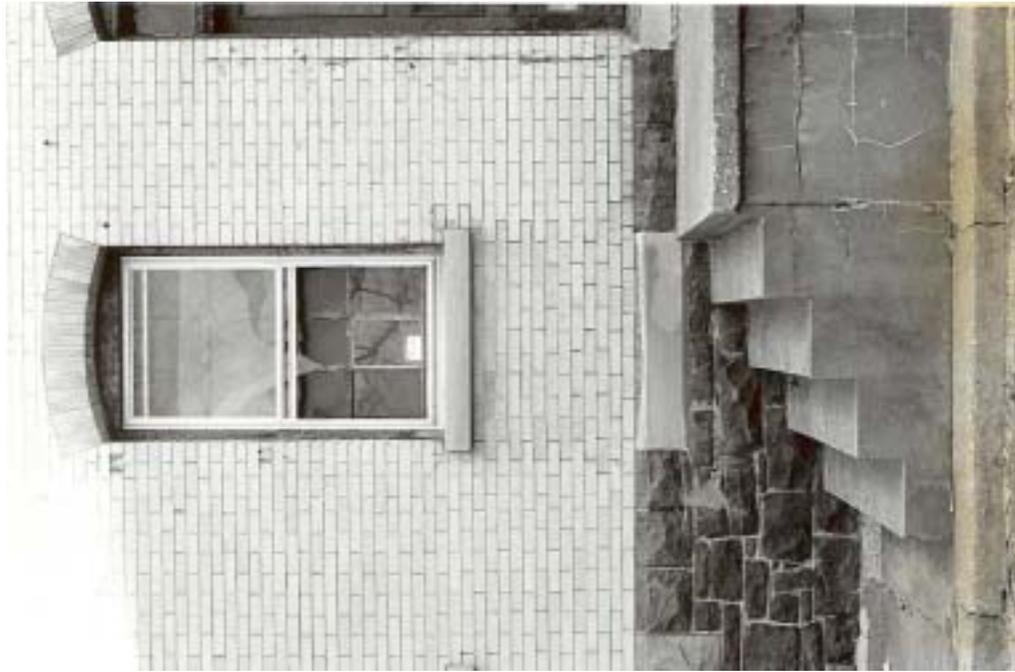
Figure 70. West elevation, former doorway converted to window (W 1-6) [1993].

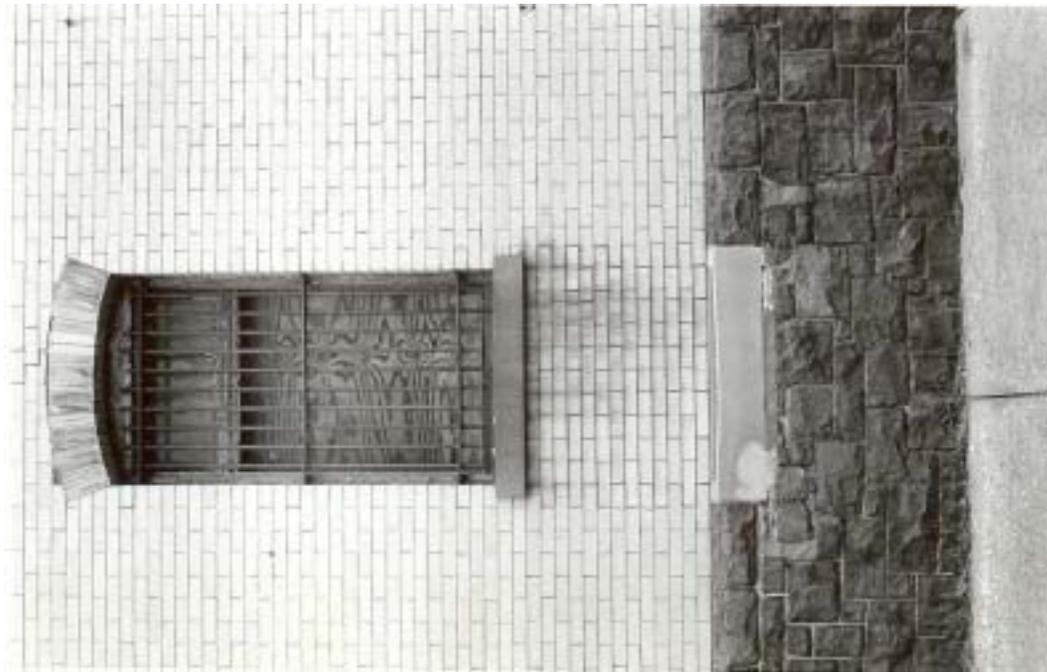
Figure 71. West elevation, former doorway converted to window (W 1-8) [1993].

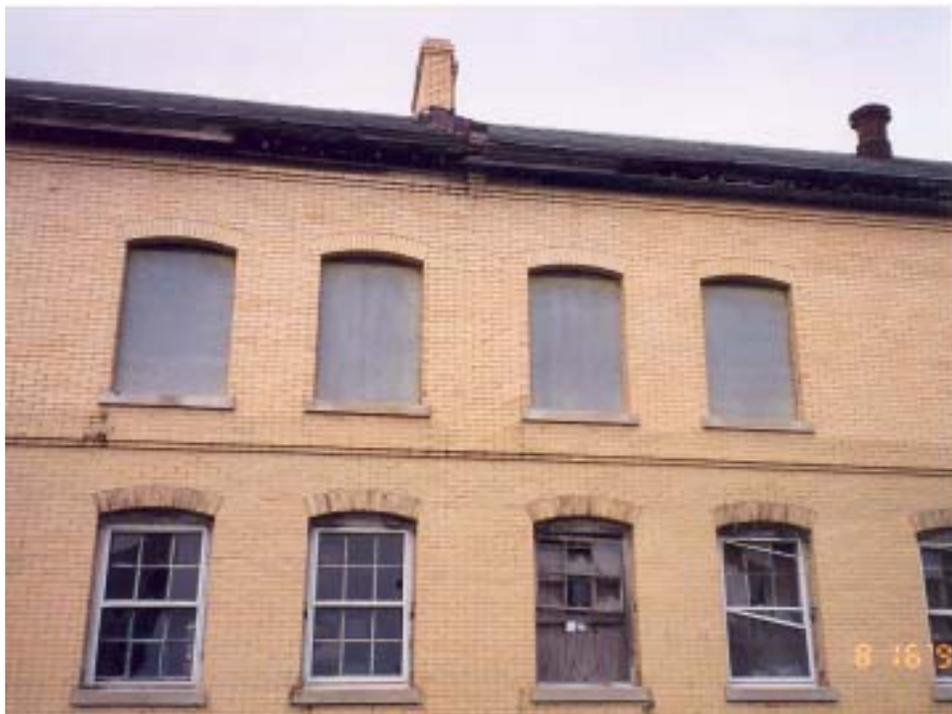
Figure 74. East elevation, second- story windows W 2- 18, 2- 19, 2- 20,
and 2- 21, added in 1910 [(1993)].

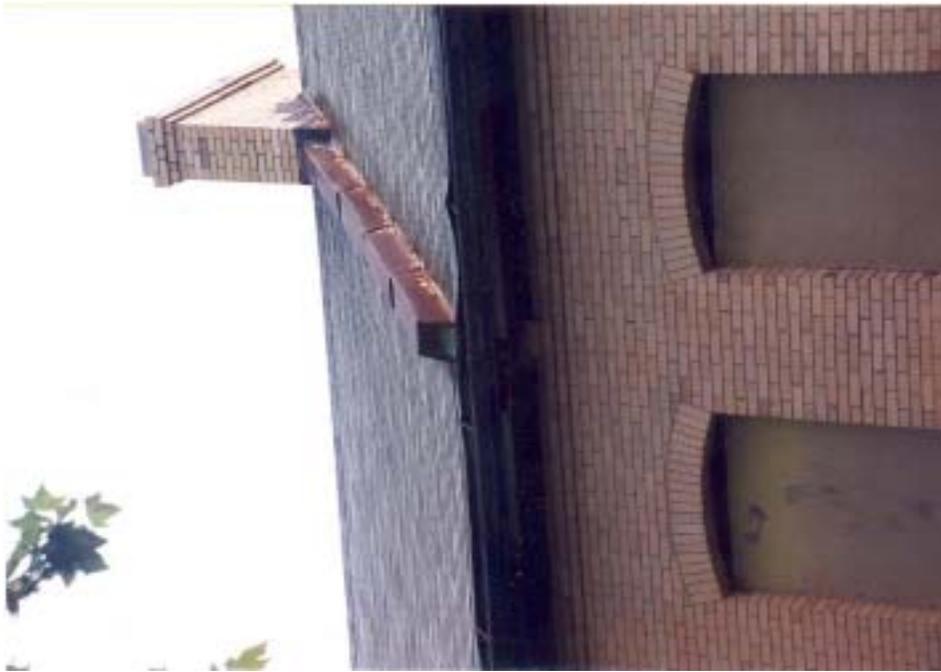
Figure 78. West elevation, deteriorated cornice between windows W 2- 14 and 2- 15 [1993].

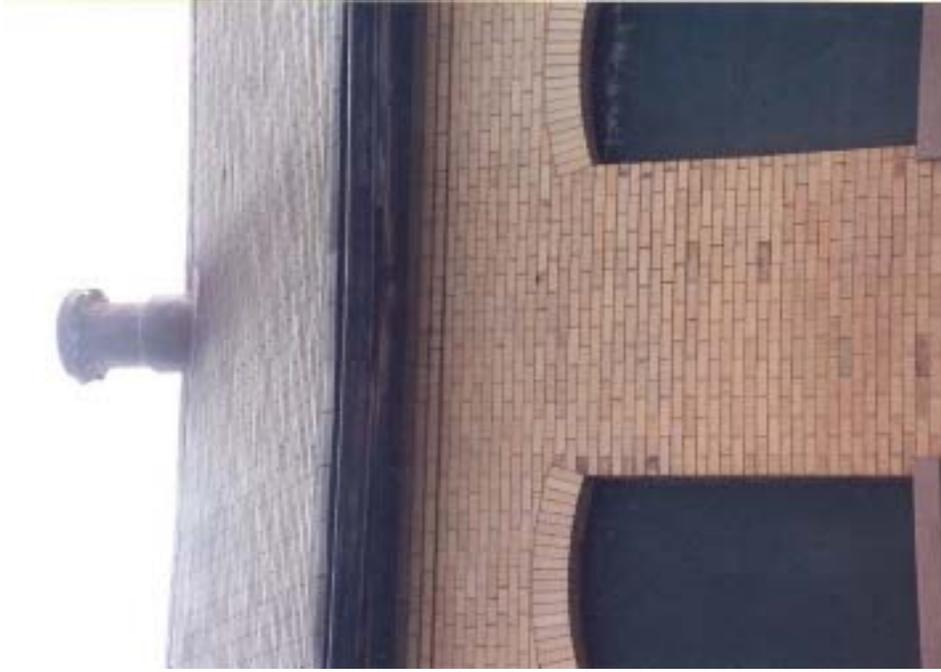
Figure 79. West slope of the roof at the fire wall and middle chimney [1993].

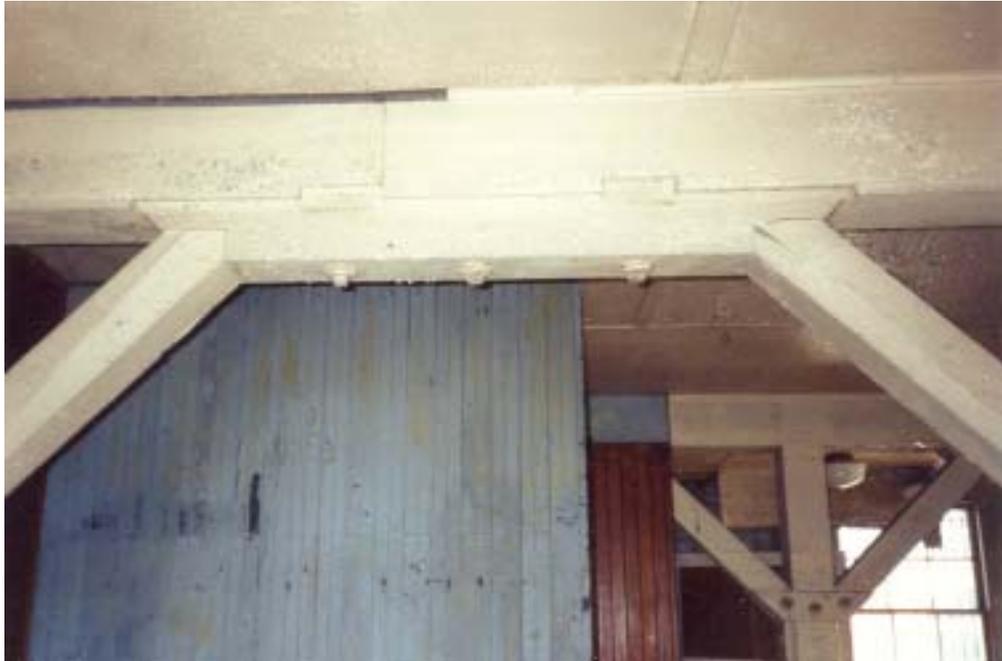
Figure 131.

The posts in Rooms 101, 102, 103, 110, and 111—the original open storage areas—are reinforced by up- braces (*see fig. 131*). Each post features one up- brace on each of its north and south sides. The tops of the up- braces are notched into a wood filler block that stretches between opposing braces and is bolted in three places to the underside of the beam (*see fig. 132*). These blocks restrain the lateral thrust of the braces. The bottom ends of the braces butt against the posts, resting on boards attached to the north and south sides of the post to support them (*see fig. 133*). These boards measure on $1\frac{3}{4}$ inches thick by $5\frac{3}{8}$ inches wide. A trapezoidal wood gusset adds strength to the V- juncture joint of post and brace. Both the board supports and the gussets restrain the downward loads of the braces. This manner of bracing allowed for extraordinary strength and support. Since the space was designed for storage, it was of primary concern that the building be able to withstand heavy weight loads.

Room 110, looking northeast at posts and bracing supporting beam; hoist housing seen in right background [1993].

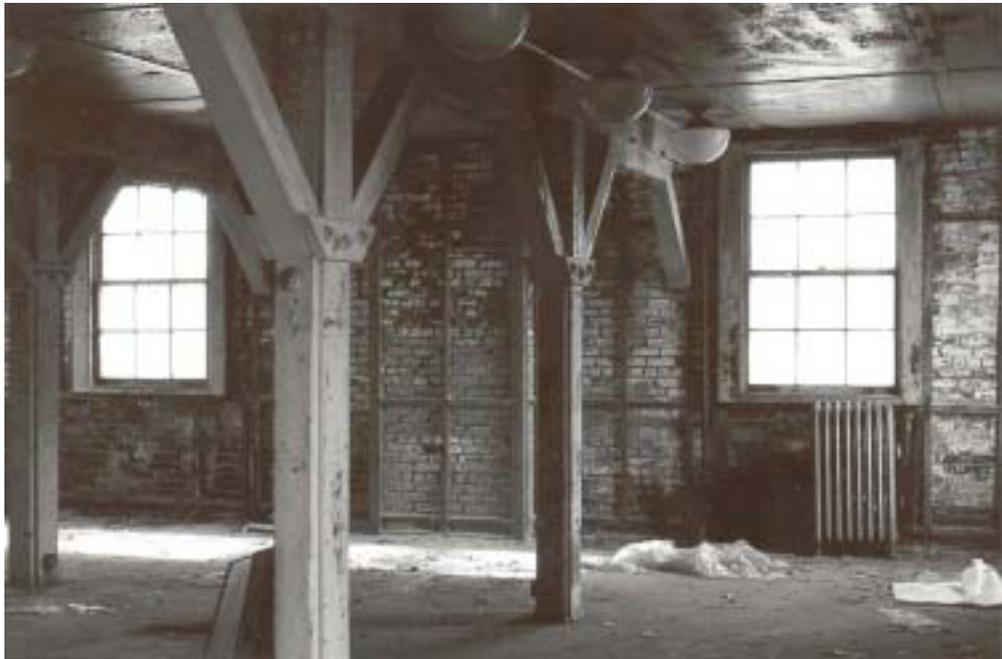
Figure 132. Room 110, looking east at detail of second- floor framing (brace support on underside of beam) [1993].

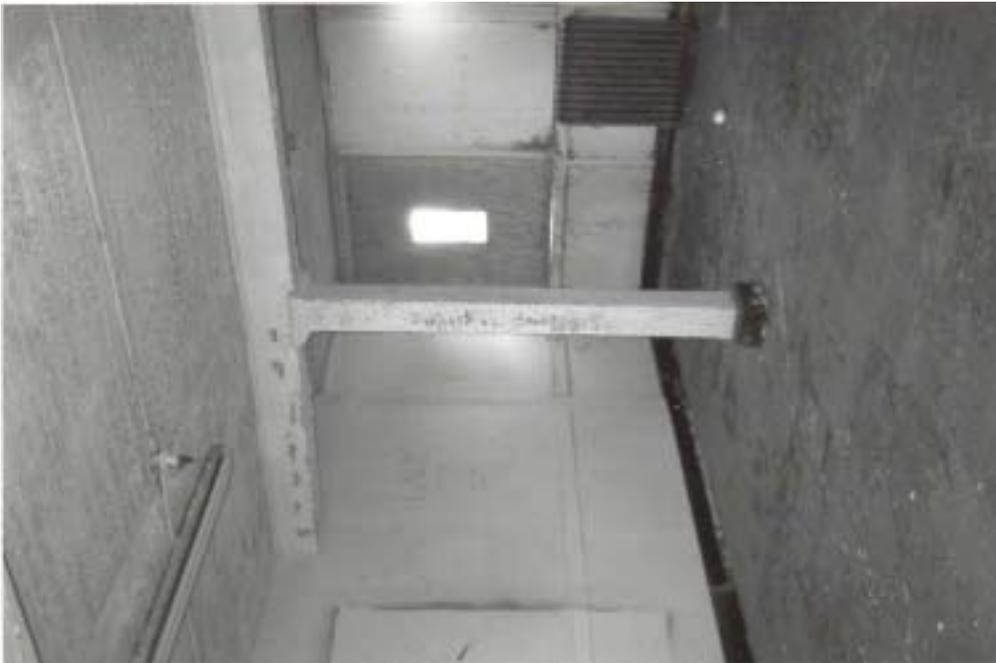
Figure 133. Room 110, looking south at framing of second floor, showing posts and bracing supporting beam [1993].

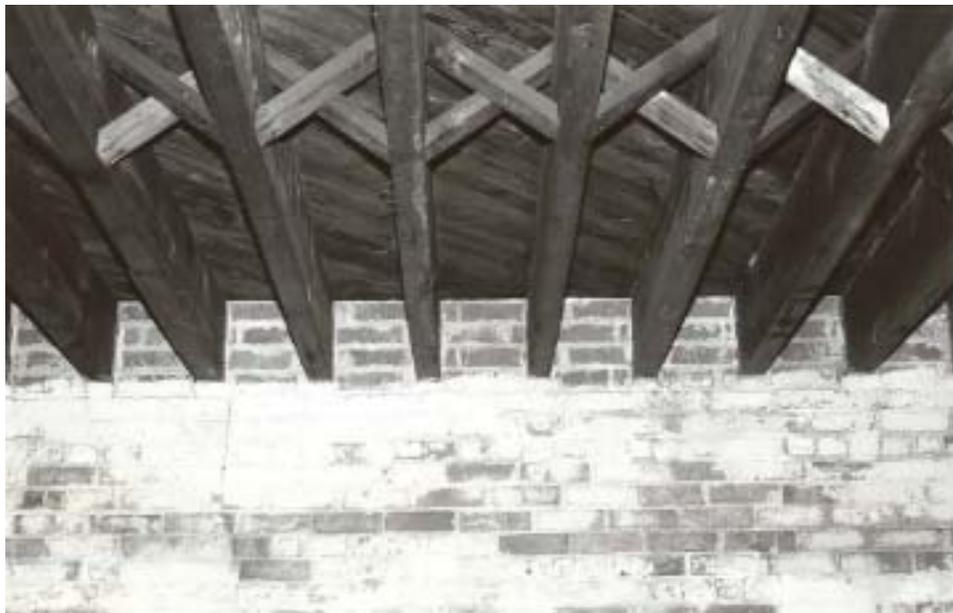
The attic- floor framing is very similar to that of the second floor, although it dates to 1910, when the roof was jacked up and a second story added to the building. The vertical supports are 6- inch- square wooden posts arranged in two parallel rows running north/south through the second story. The posts are located approximately 9 feet on center; they extend down through the floor to rest directly on the floor- framing beams below. The top and bottom of each post is square. All four edges have a three- quarter- inch chamfer with a lamb's tongue detail at each end, $7\frac{1}{4}$ inches from the top and 12 inches from the bottom. The effect gives each post the appearance of a squared cap and base with a slimmer shaft (*see fig. 135*).

Timber beams measuring 8 by 13 inches run north/south and rest on top of the posts. The ends of the beams are set into the brickwork of the north and south end walls, and into the fire wall in the middle of the building. The beams are cased with horizontal beaded boards (*see fig. 135*). They support the attic- floor joists, which run east/west. The ends of the joists are let into the masonry of the east and west walls to a depth of approximately 6 inches. The joists measure 3 by 10 inches and are located 12 inches on center. The area between the joists features three north/south rows of cross- bridging bracing the joist spans (*see figs. 136- 137*). Cross- bridging consists of two pieces, measuring 1 ¾ inches by 3 inches, that form an “X” toe- nailed to the inner faces of the joists.

Figure 135. Room 210, looking northwest at attic-floor framing (cased post and beam) [1993].

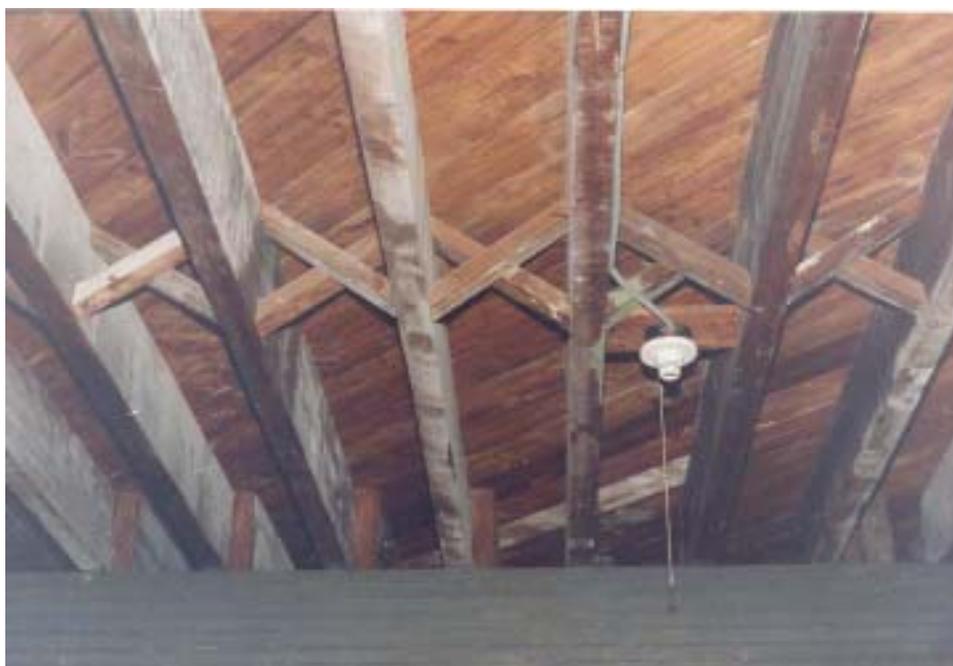
Figure 136. Room 201, west wall: attic- floor framing (joists and cross-bridging) and diagonally laid floorboards [1993].

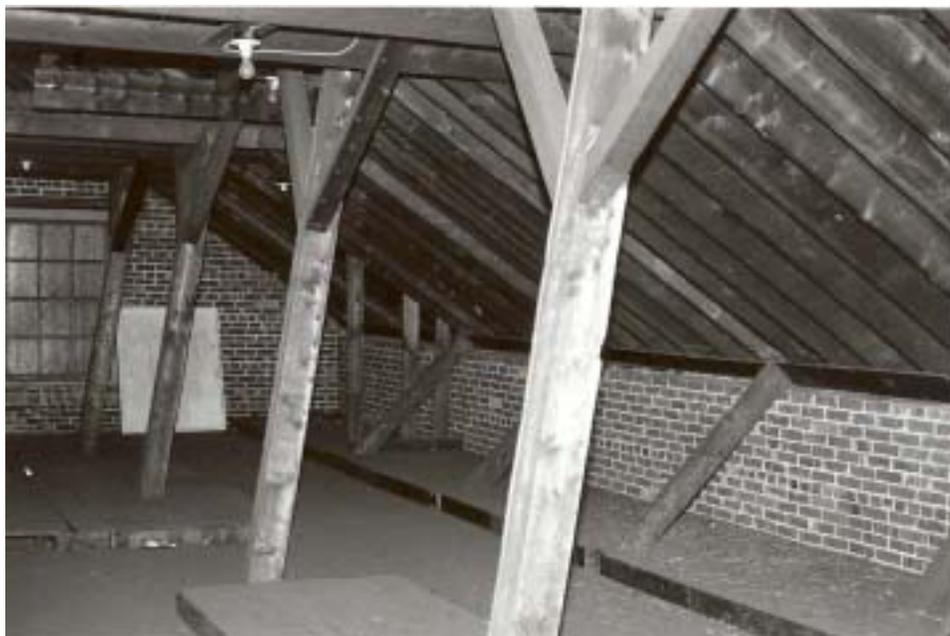
Figure 137. Room 210, looking west at attic- floor framing (joists, cross-bridging, and beam) [1993].

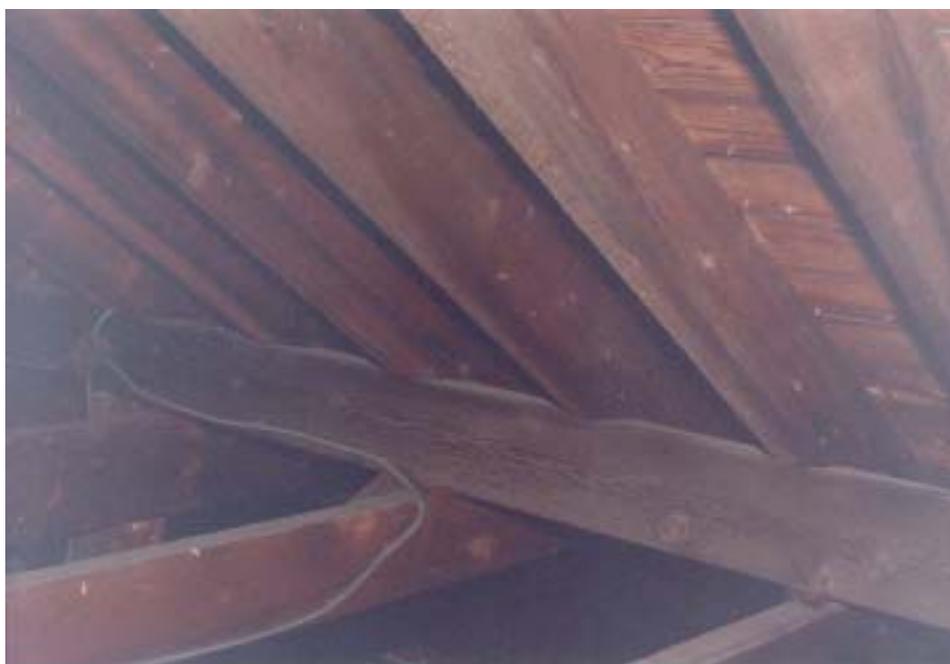
In the attic, the brick west and east side walls extend 37 ½ inches above the attic flooring (*see fig. 138*). Rafters measuring 2 by 8 inches are notched into the wood plate at the top of these walls; their ends overhang the exterior of the walls by 12 inches. Rafters are spaced every 16 inches on center. There are 47 rafters in the north part of the attic and 42 rafters in the south part. The tops of the rafters are toe- nailed to a 2- by- 10- inch ridge board at the peak of the roof.

Figure 138. Room 302 (south part of attic), looking south along west wall at roof framing [1993].

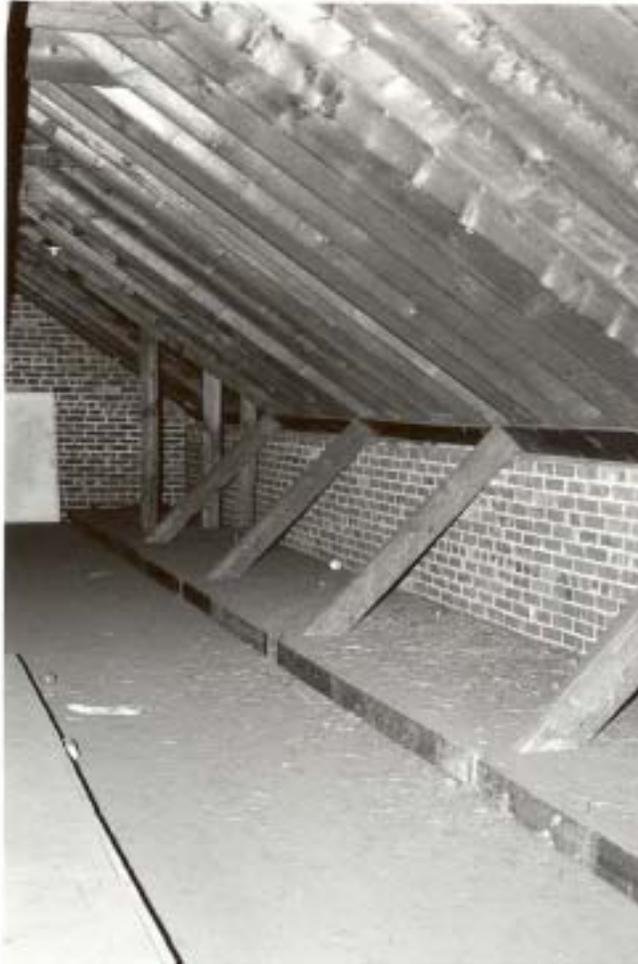
Figure 14o. Room 301 (north part of attic), southwest corner: roof framing (angled post and braces) [1993].

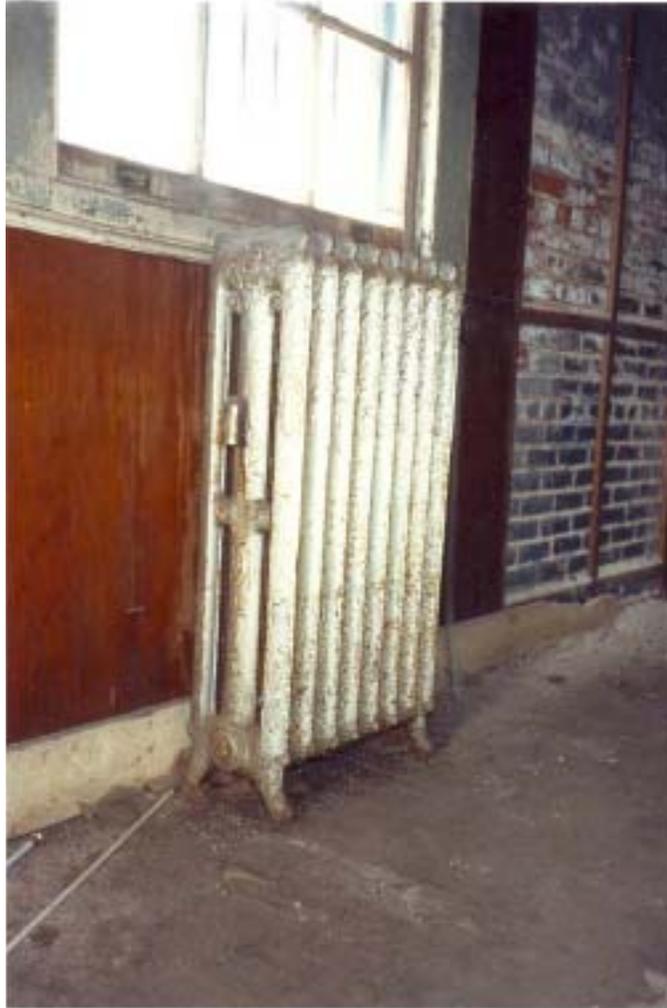
Freestanding radiators from a former single- pipe steam- heating system remain in the first and second stories. There are nine radiators in the first story (*fig. 143*); these are ornate cast- iron radiators probably dating to ca. 1925, when a new heater was purchased for the building. There are nine modern "ARCO" coil radiators in the second story.

Figure 143. Room 110, west wall: cast- iron radiator under window W 1- 9 [1993].

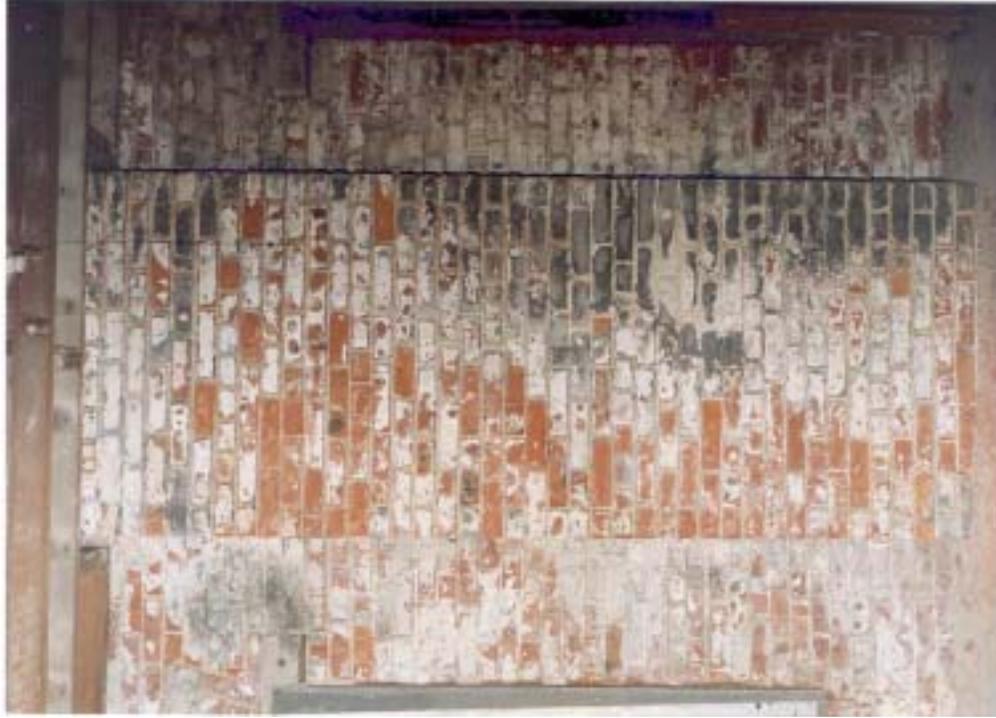
Finally, two of the three chimneys in the original design remain in place (*fig. 144*). These served an original heating system consisting of stoves. The section and first- floor plan included in the 1894 and 1897 design drawings show stovepipe holes leading from the chimney into first- story rooms. When the second story was added in 1910, the chimneys were retained and heightened to extend through the new level (*fig. 145*). This suggests that stoves were still being used to heat the building at that time.

Figure 145. Room 210, south wall: projecting chimney breast [1993]
